Debris/Ice/TPS Assessment And Integrated Photographic Analysis For Shuttle Mission STS-45

May 1992

Gregory N. Katnik
NASA/Kennedy Space Center

March 24, 1992

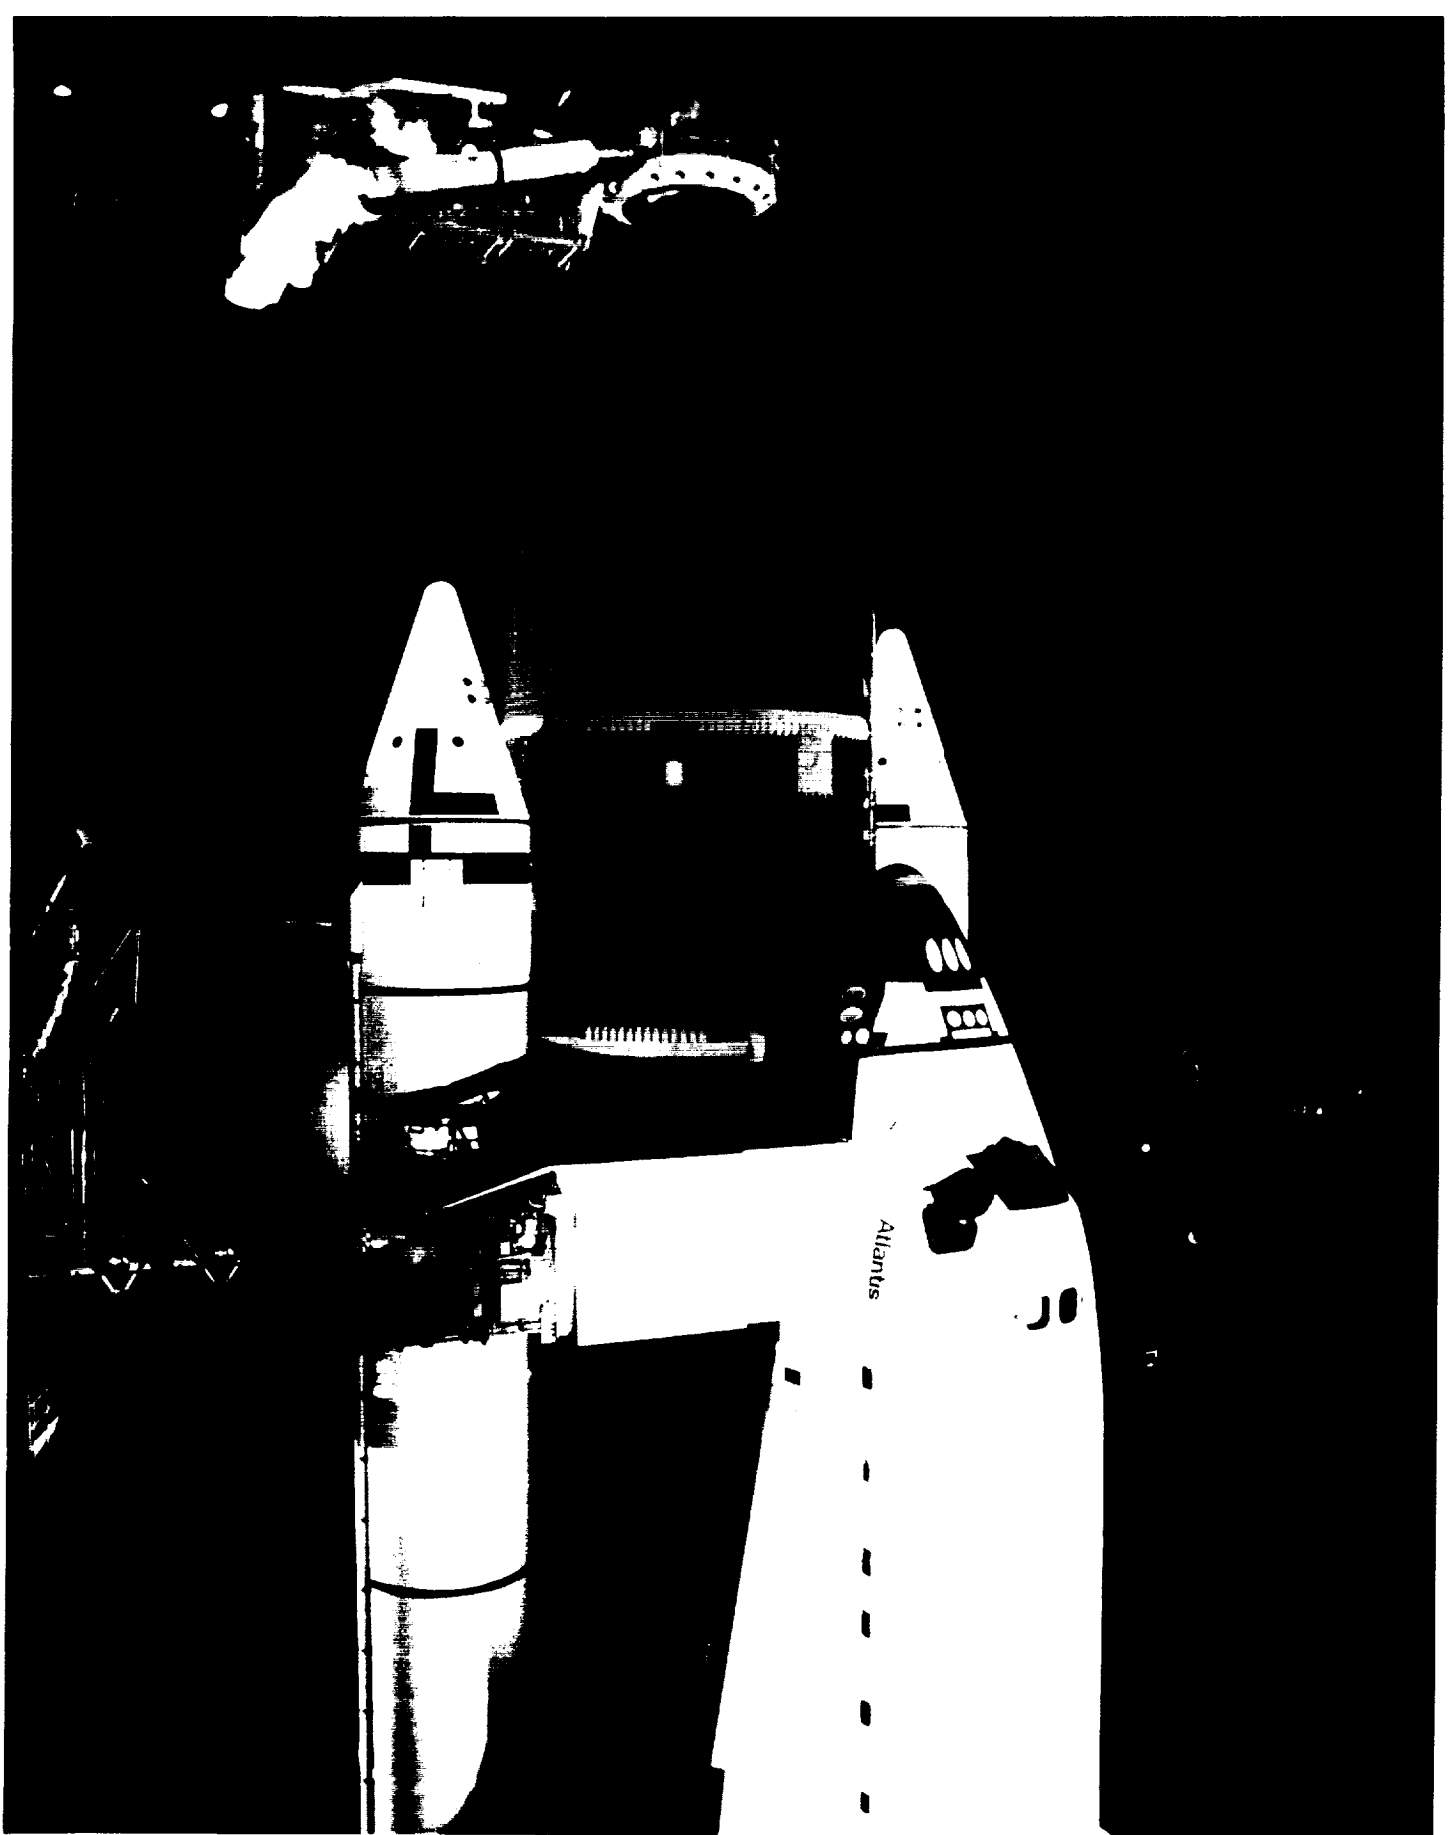
Light condensate, but no ice or frost, had accumulated on the
ET LO2 tank ogive and barrel sections

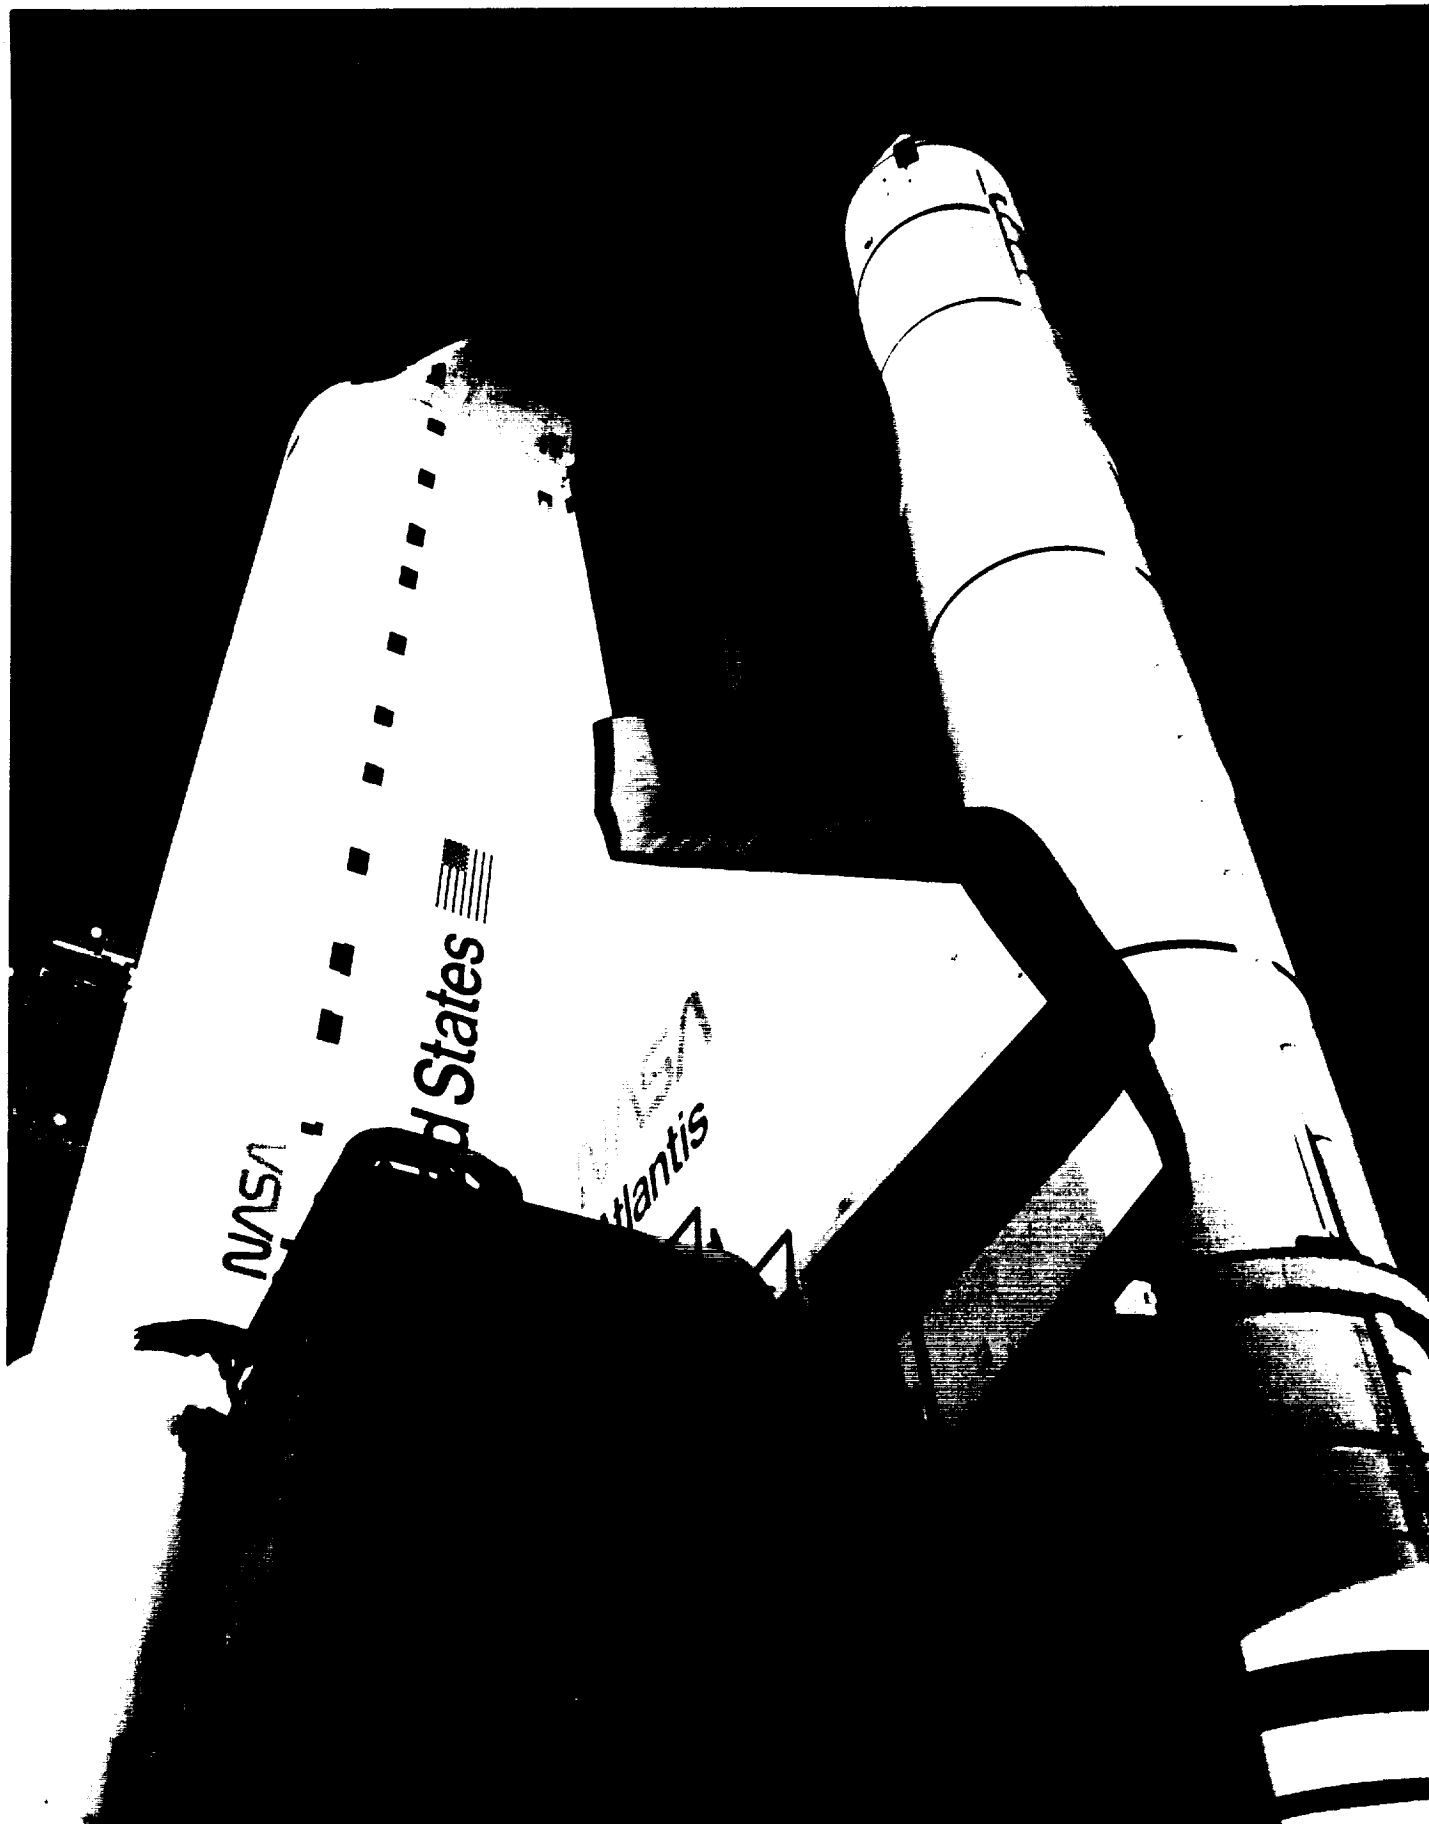
There were no LH2 tank TPS anomalies. Light condensate, but no ice or frost, was present on the acreage and aft dome.

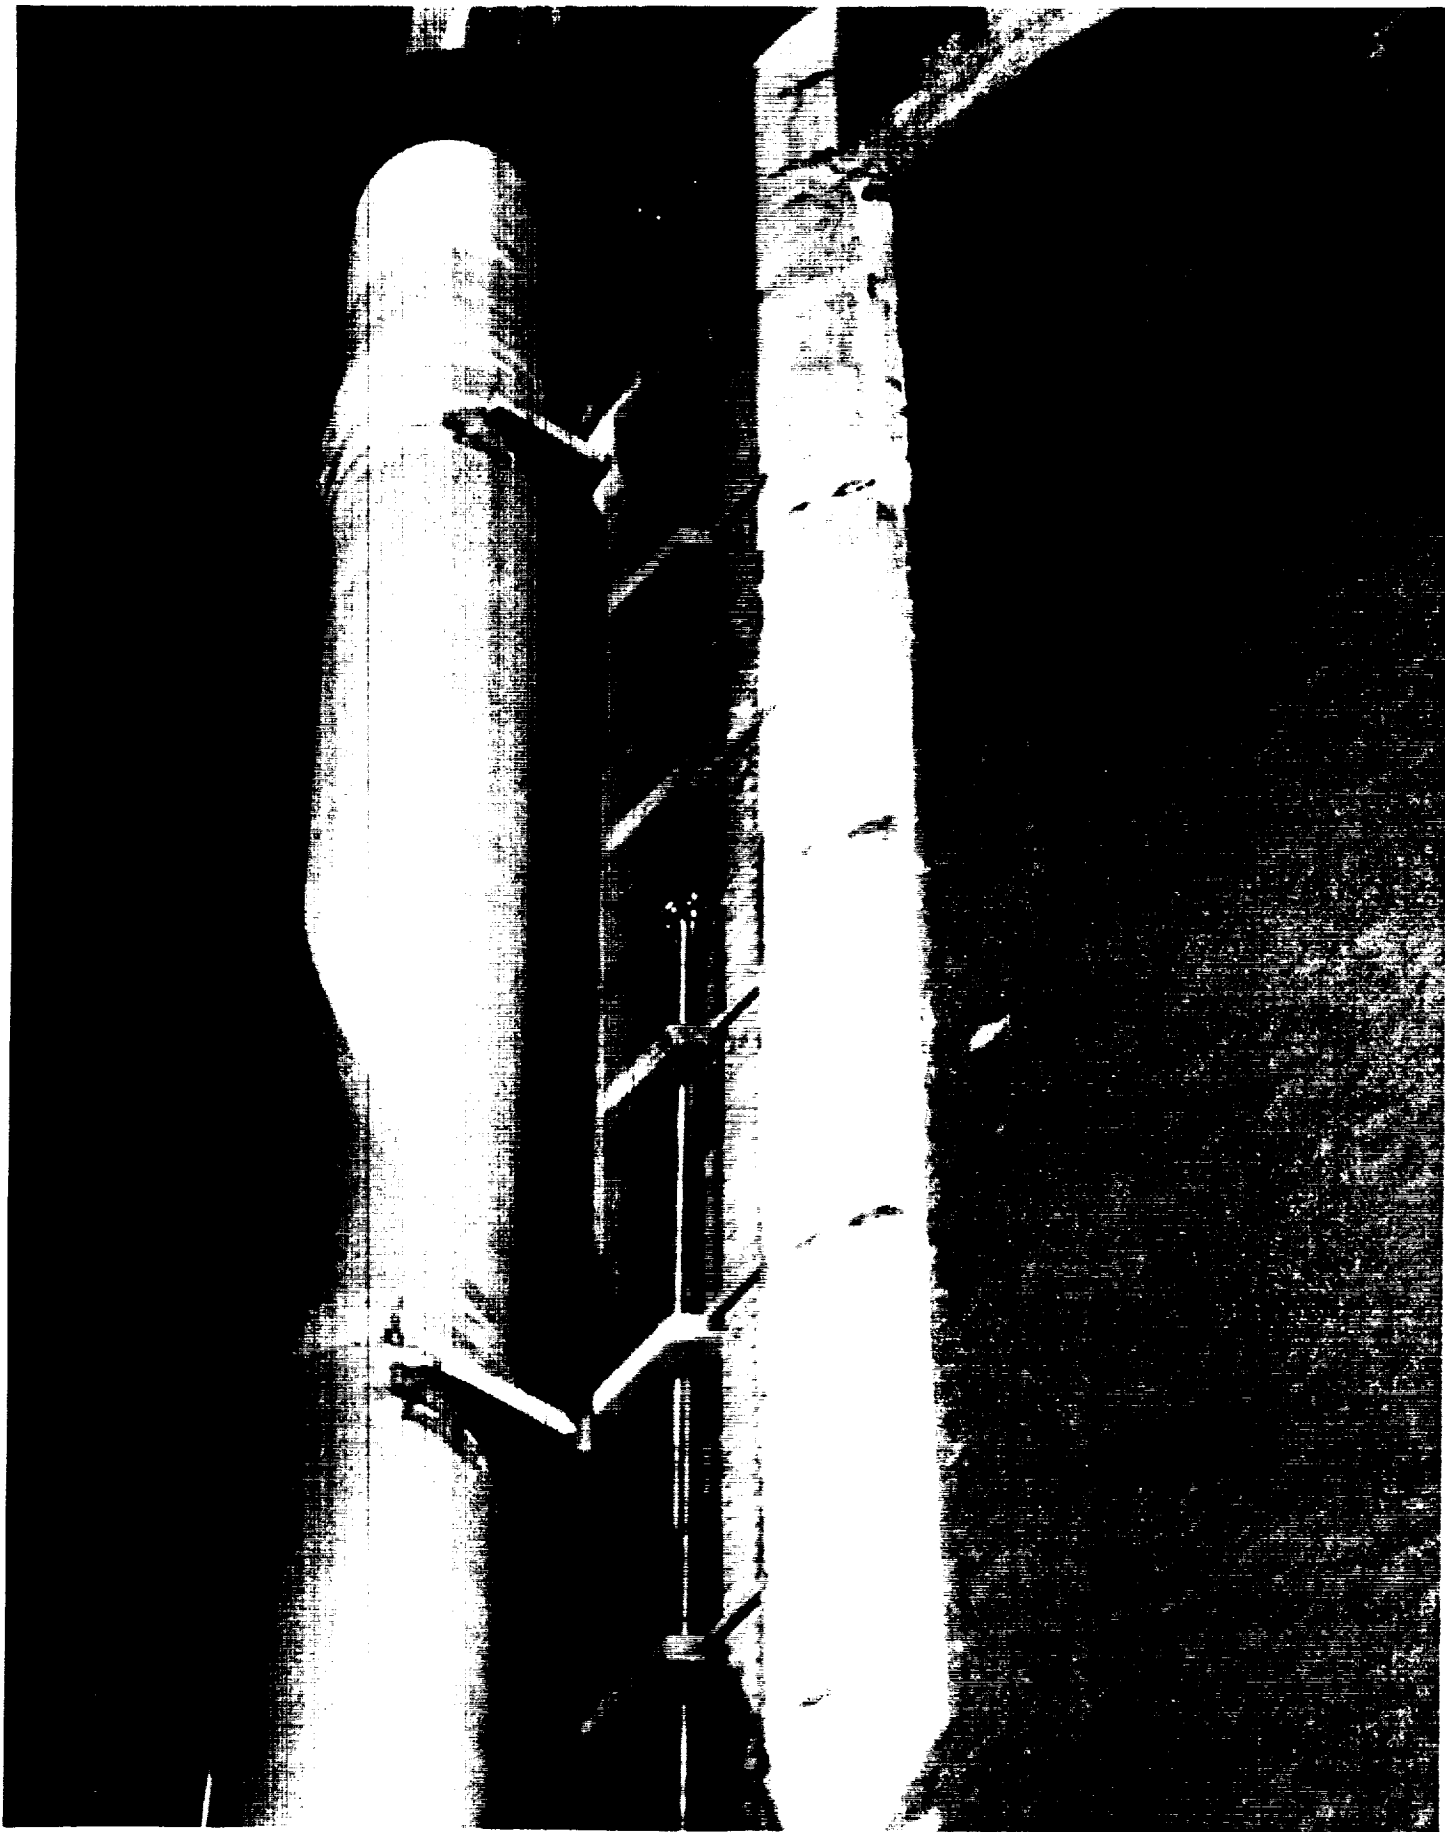
Ice/frost formations in the L02 feedline support brackets and upper bellows were acceptable per the NSTS-08303 criteria.

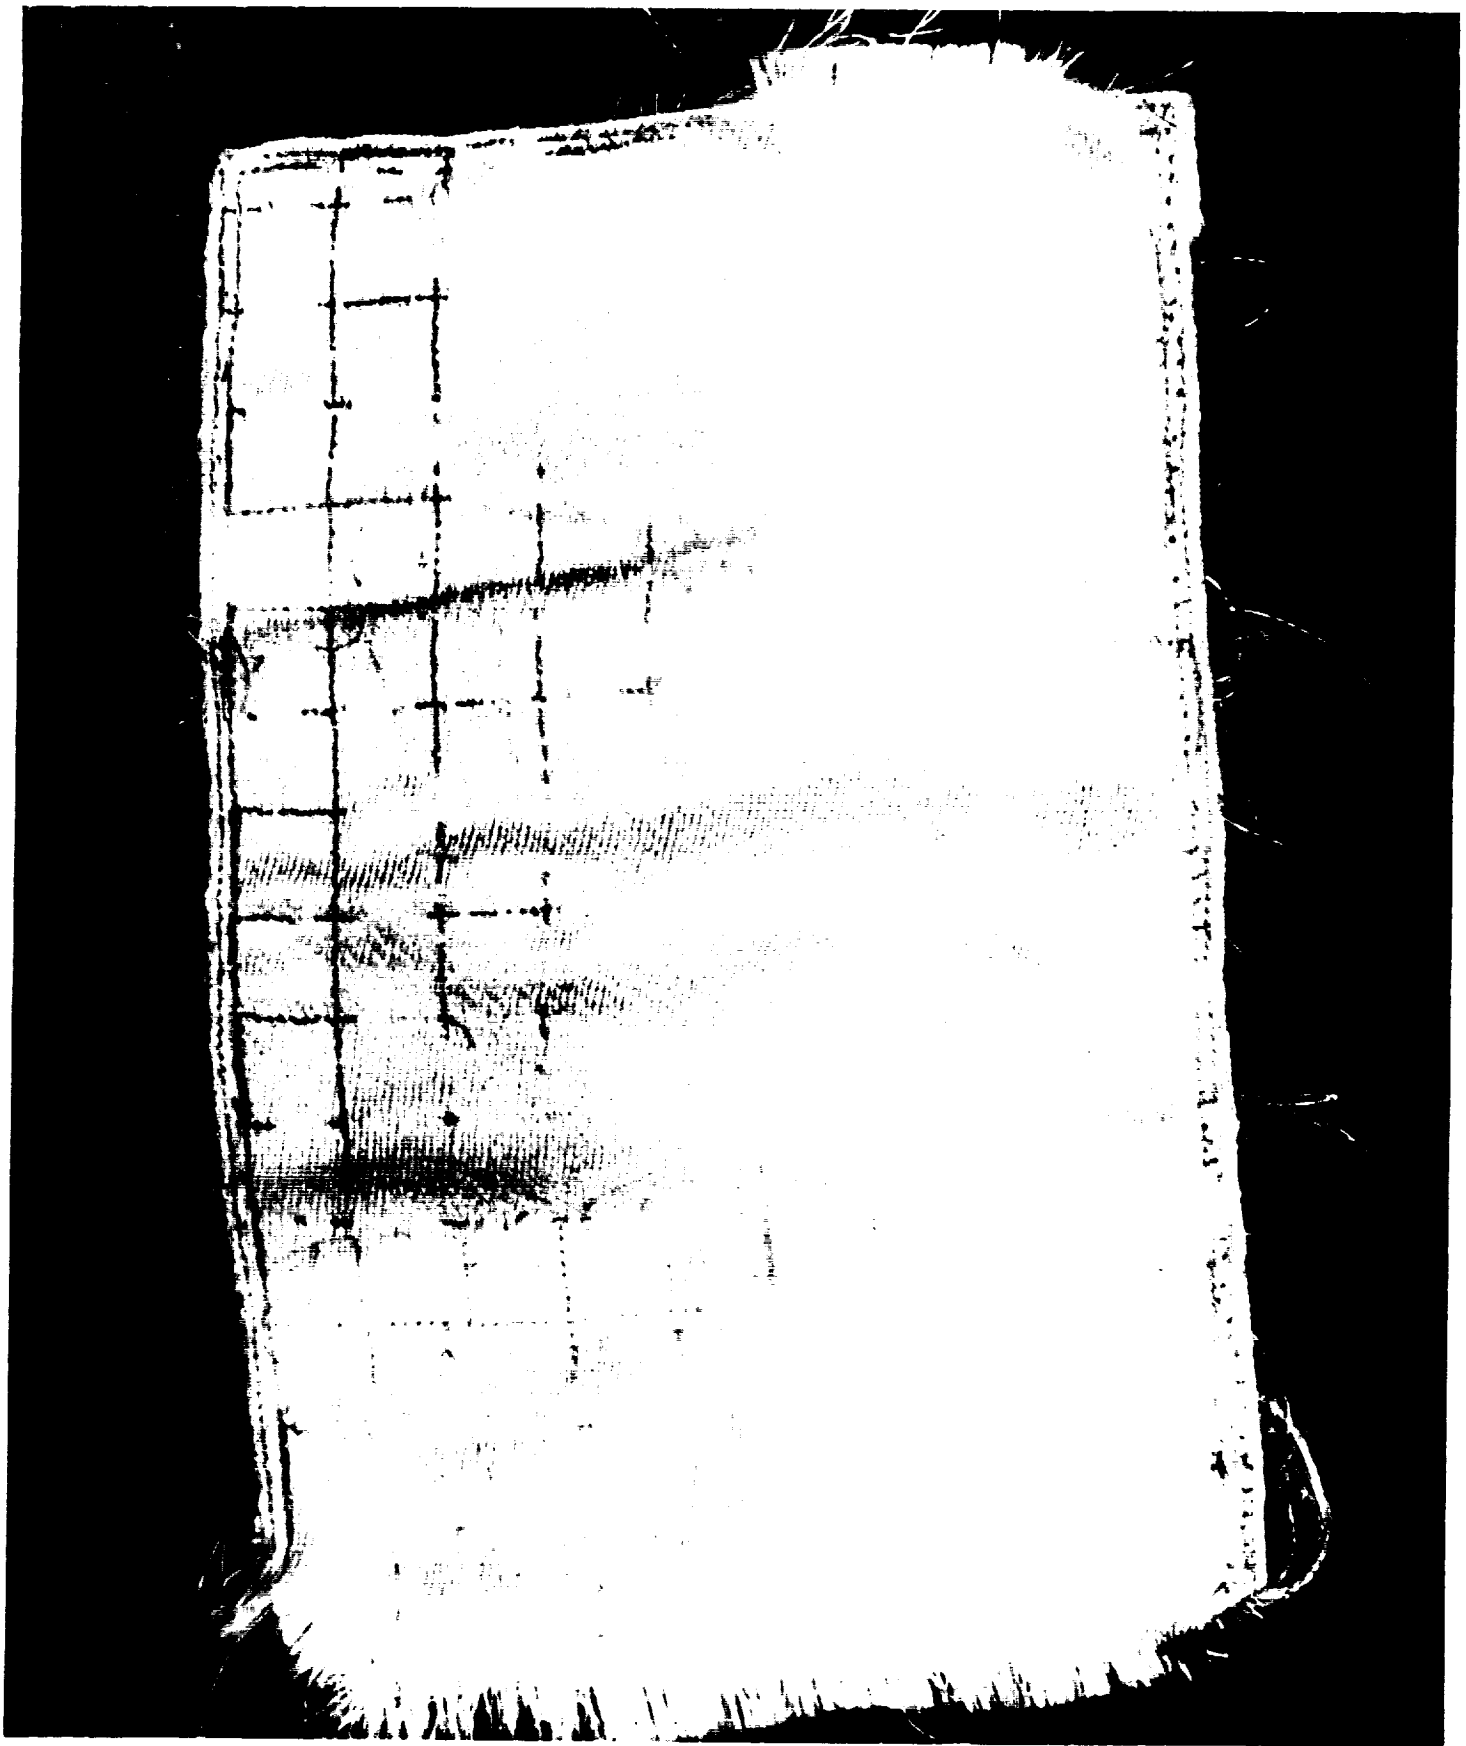
Two pieces of SSME Dome Mounted Heat Shield (DMHS) thermal protection blanket sacrificial patches, each measuring 11"x16", were found southwest of the pad apron. Film review showed the patches falling aft of the SSME area at 31 seconds MET.

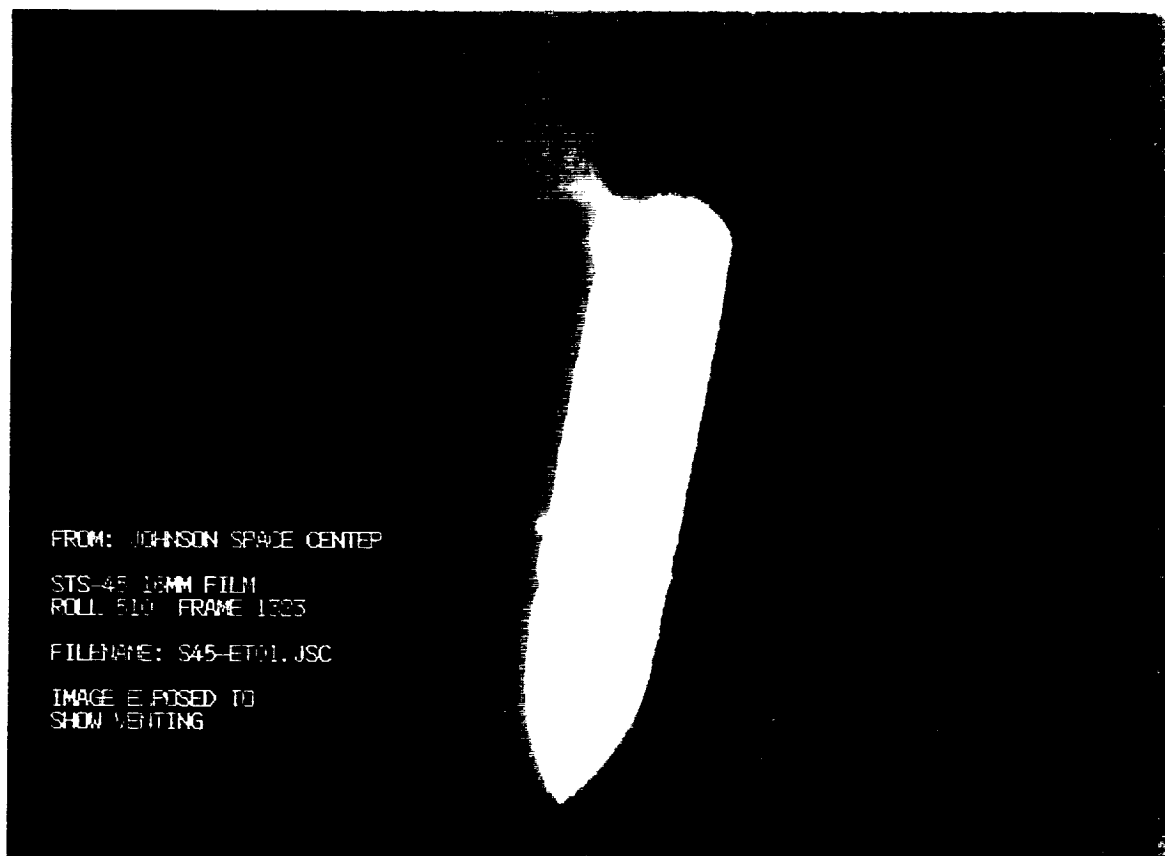
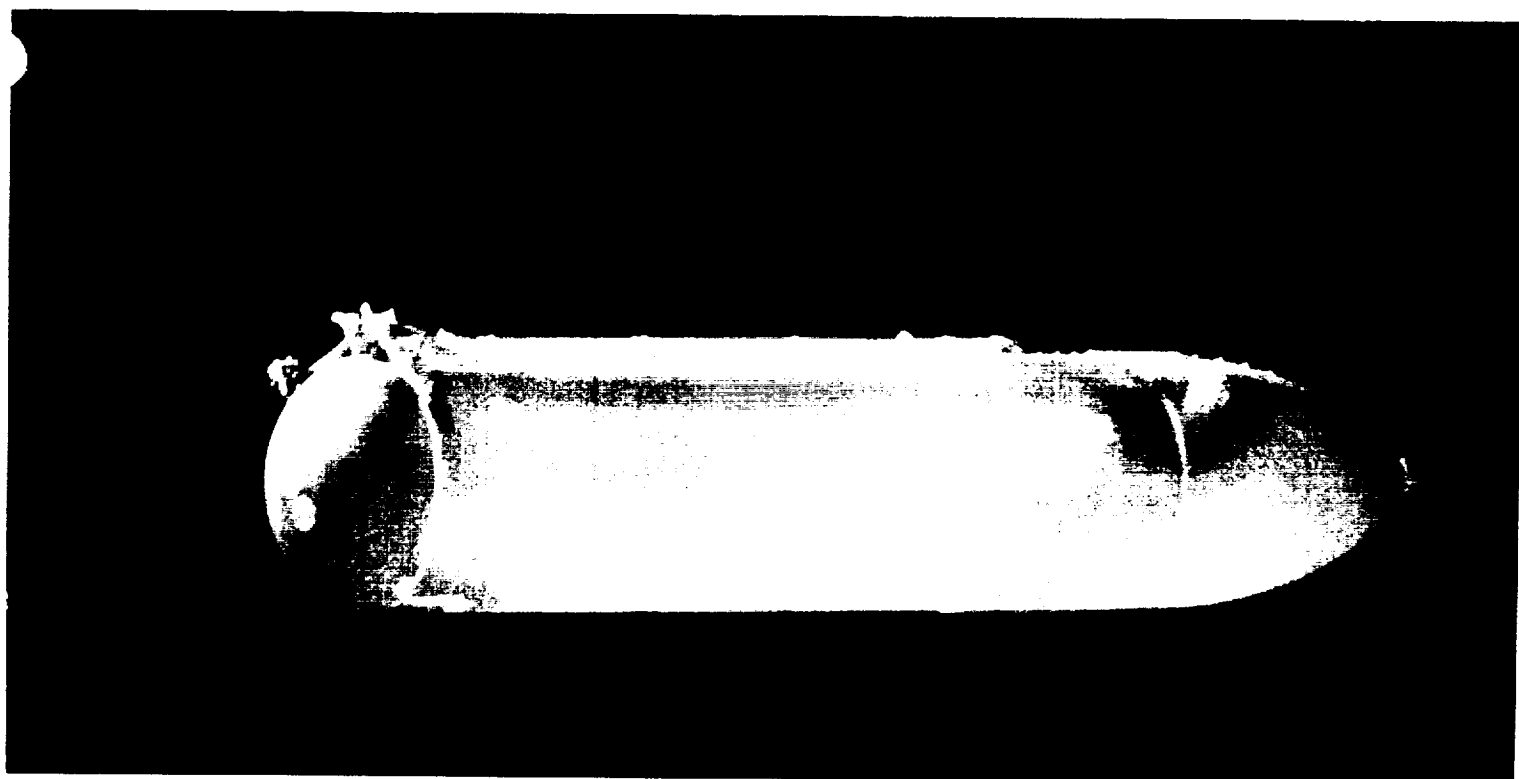
Exposure-adjusted views of the External Tank shortly after separation from the Orbiter show a conical shaped feature believed to be residual hydrogen venting from the LH2 ET/ORB umbilical 4-inch recirculation line interface area.

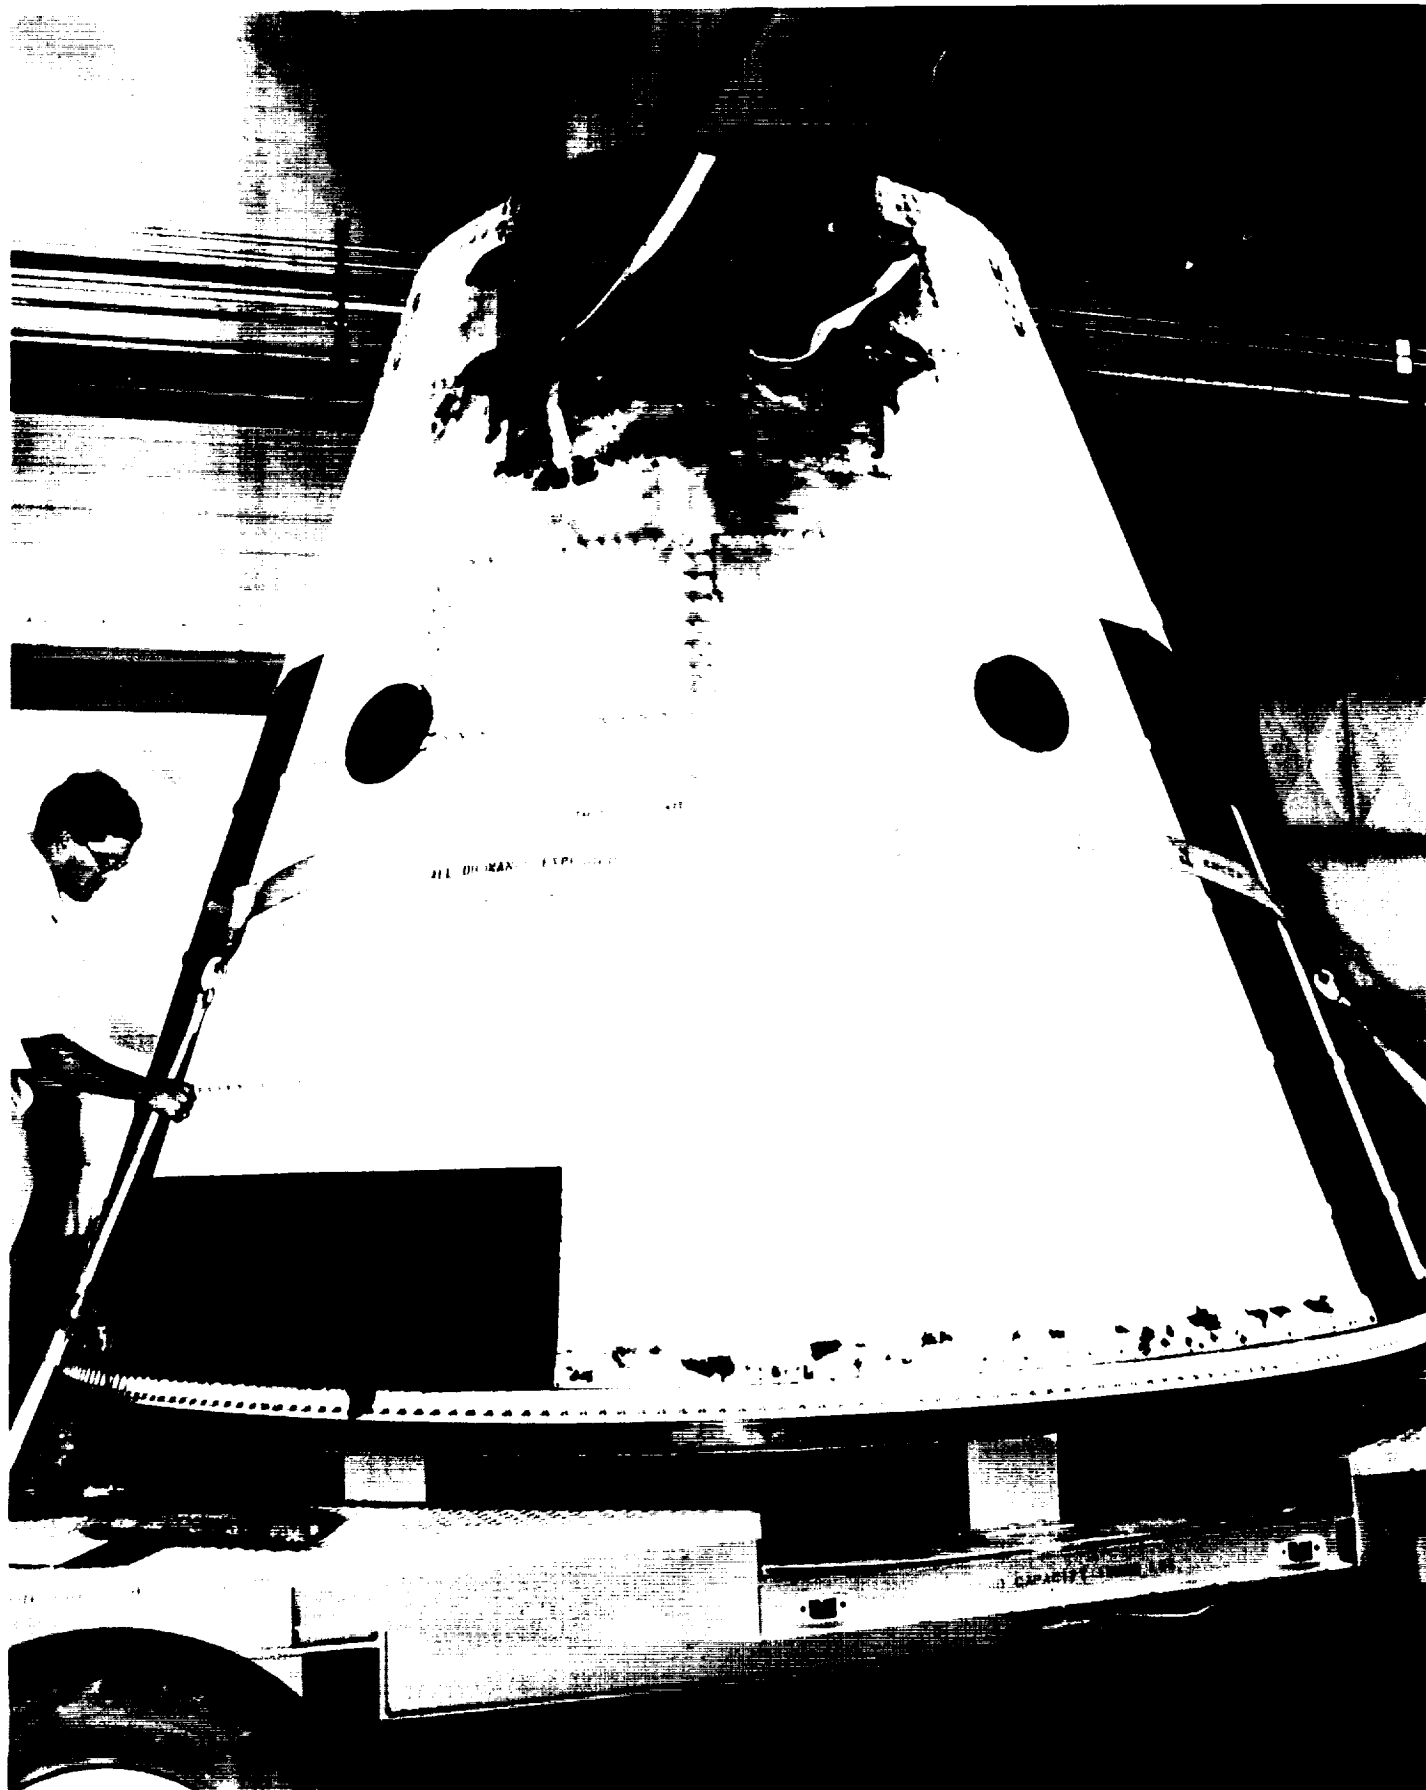
The RH frustum was missing no TPS but had 10 MSA-2 debonds over fasteners. The Hypalon paint was severely blistered and peeling the full circumference of the 395 ring frame and around the BSM area.

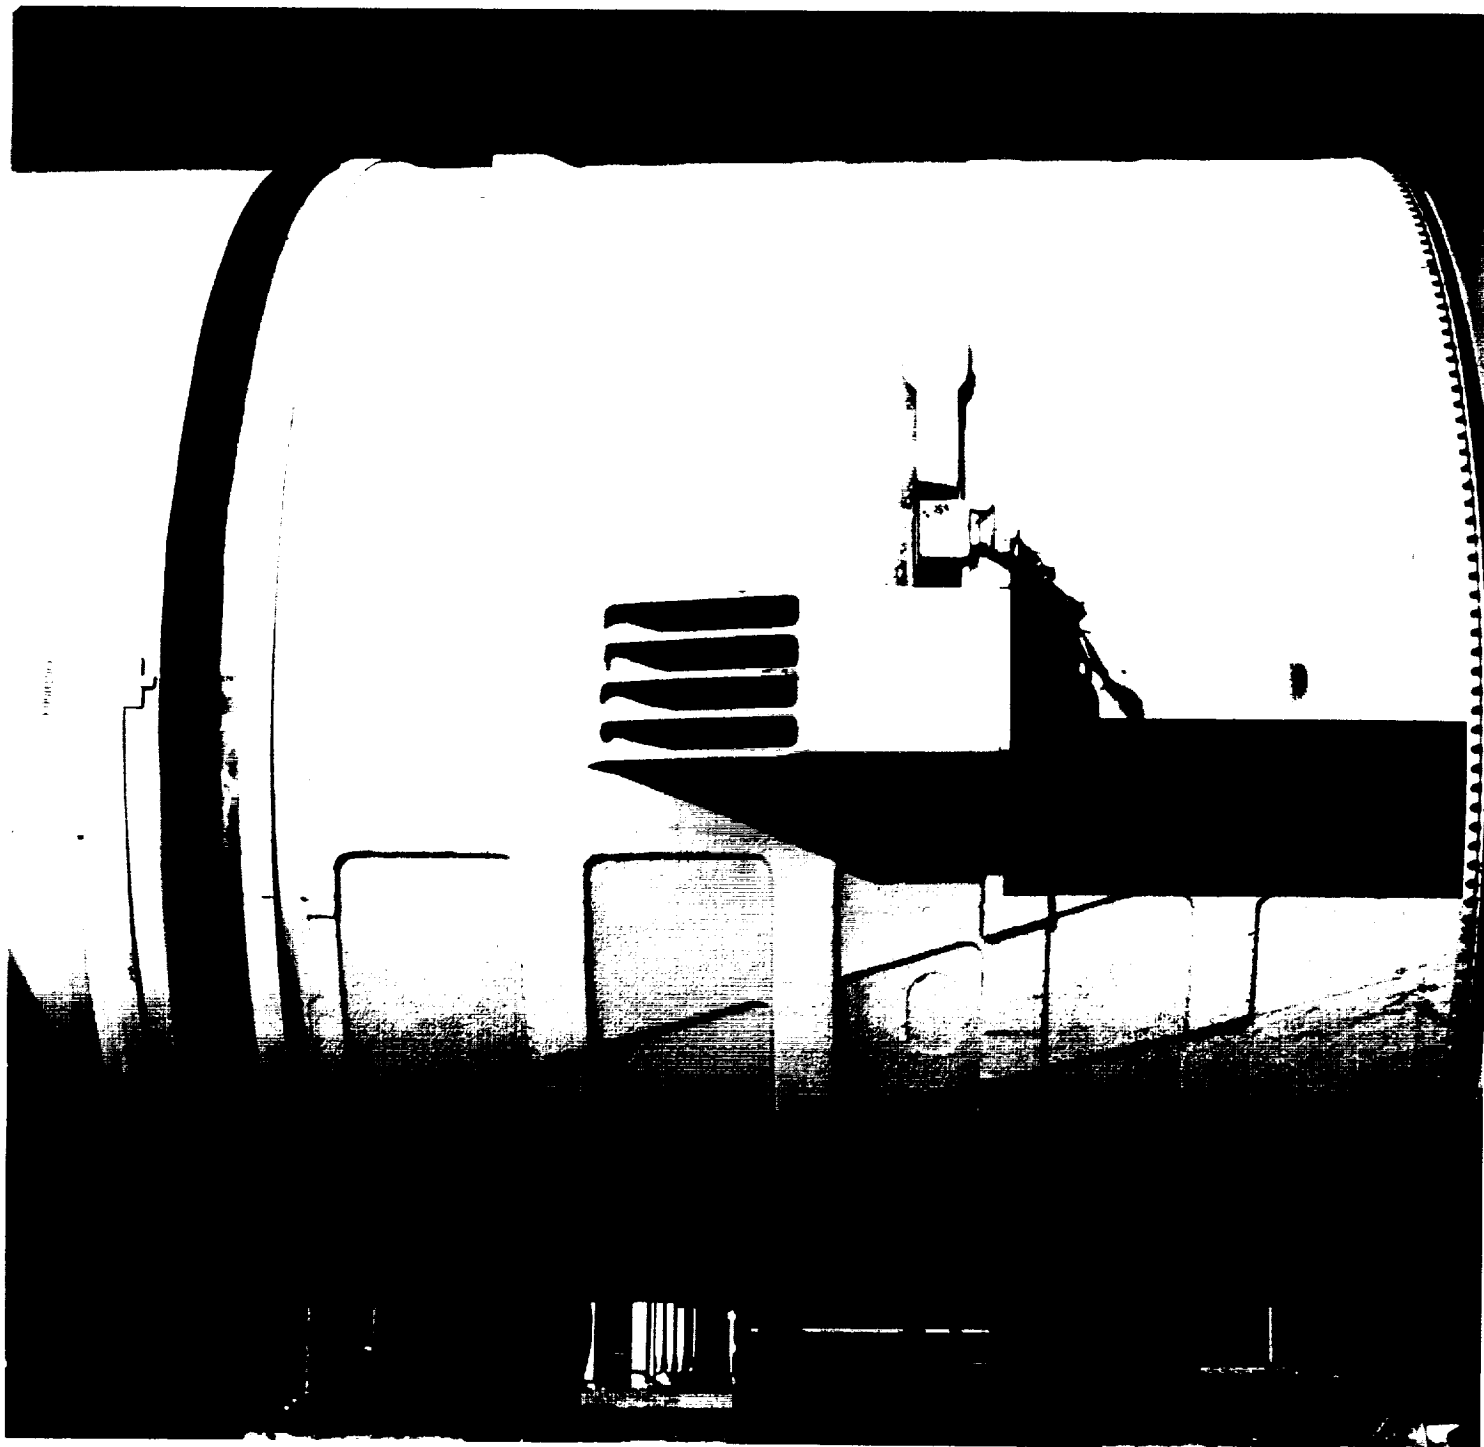
The RH forward skirt exhibited no debonds or missing TPS. Both RSS antenna phenolic plates were intact. No hardware was missing from the forward skirt that could have caused the damage to the RCC panel #10 on the Orbiter right wing leading edge.

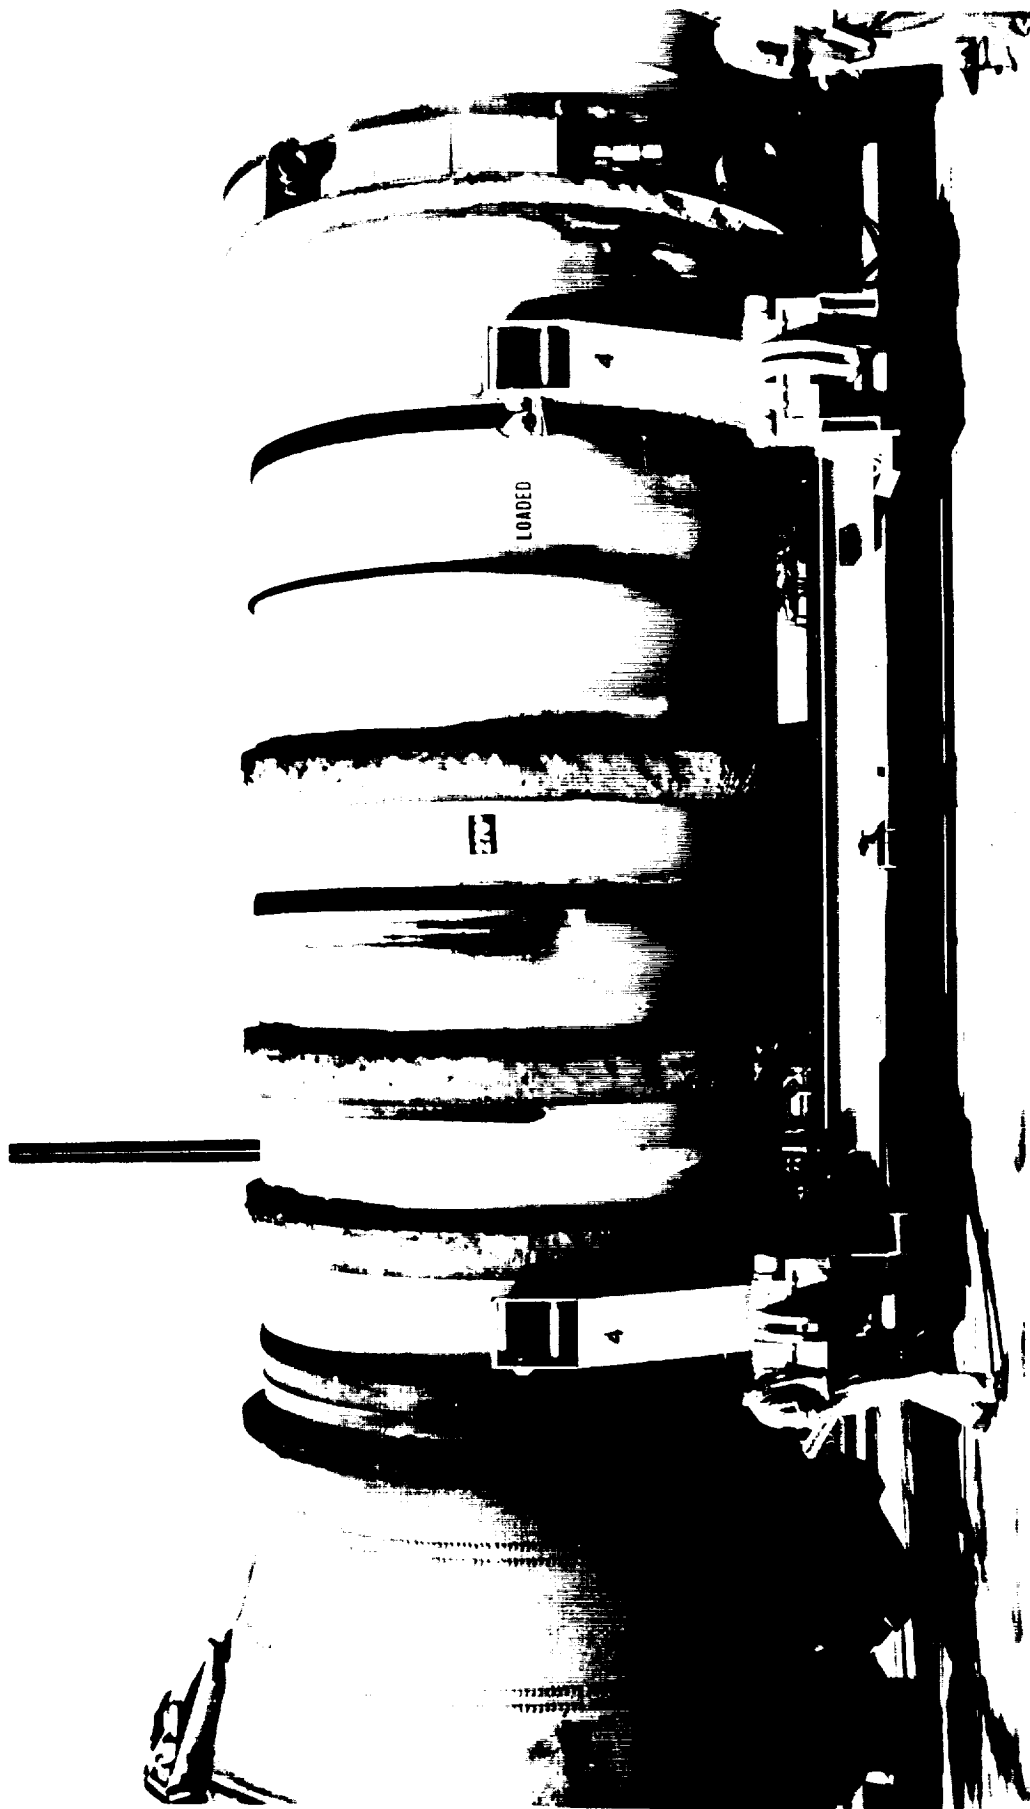
Post flight condition of the RH aft booster. The aft skirt acreage TPS was sooted but in good condition. The ET/SRB aft struts, ETA ring, IEA, and all three aft booster stiffener rings appeared undamaged.

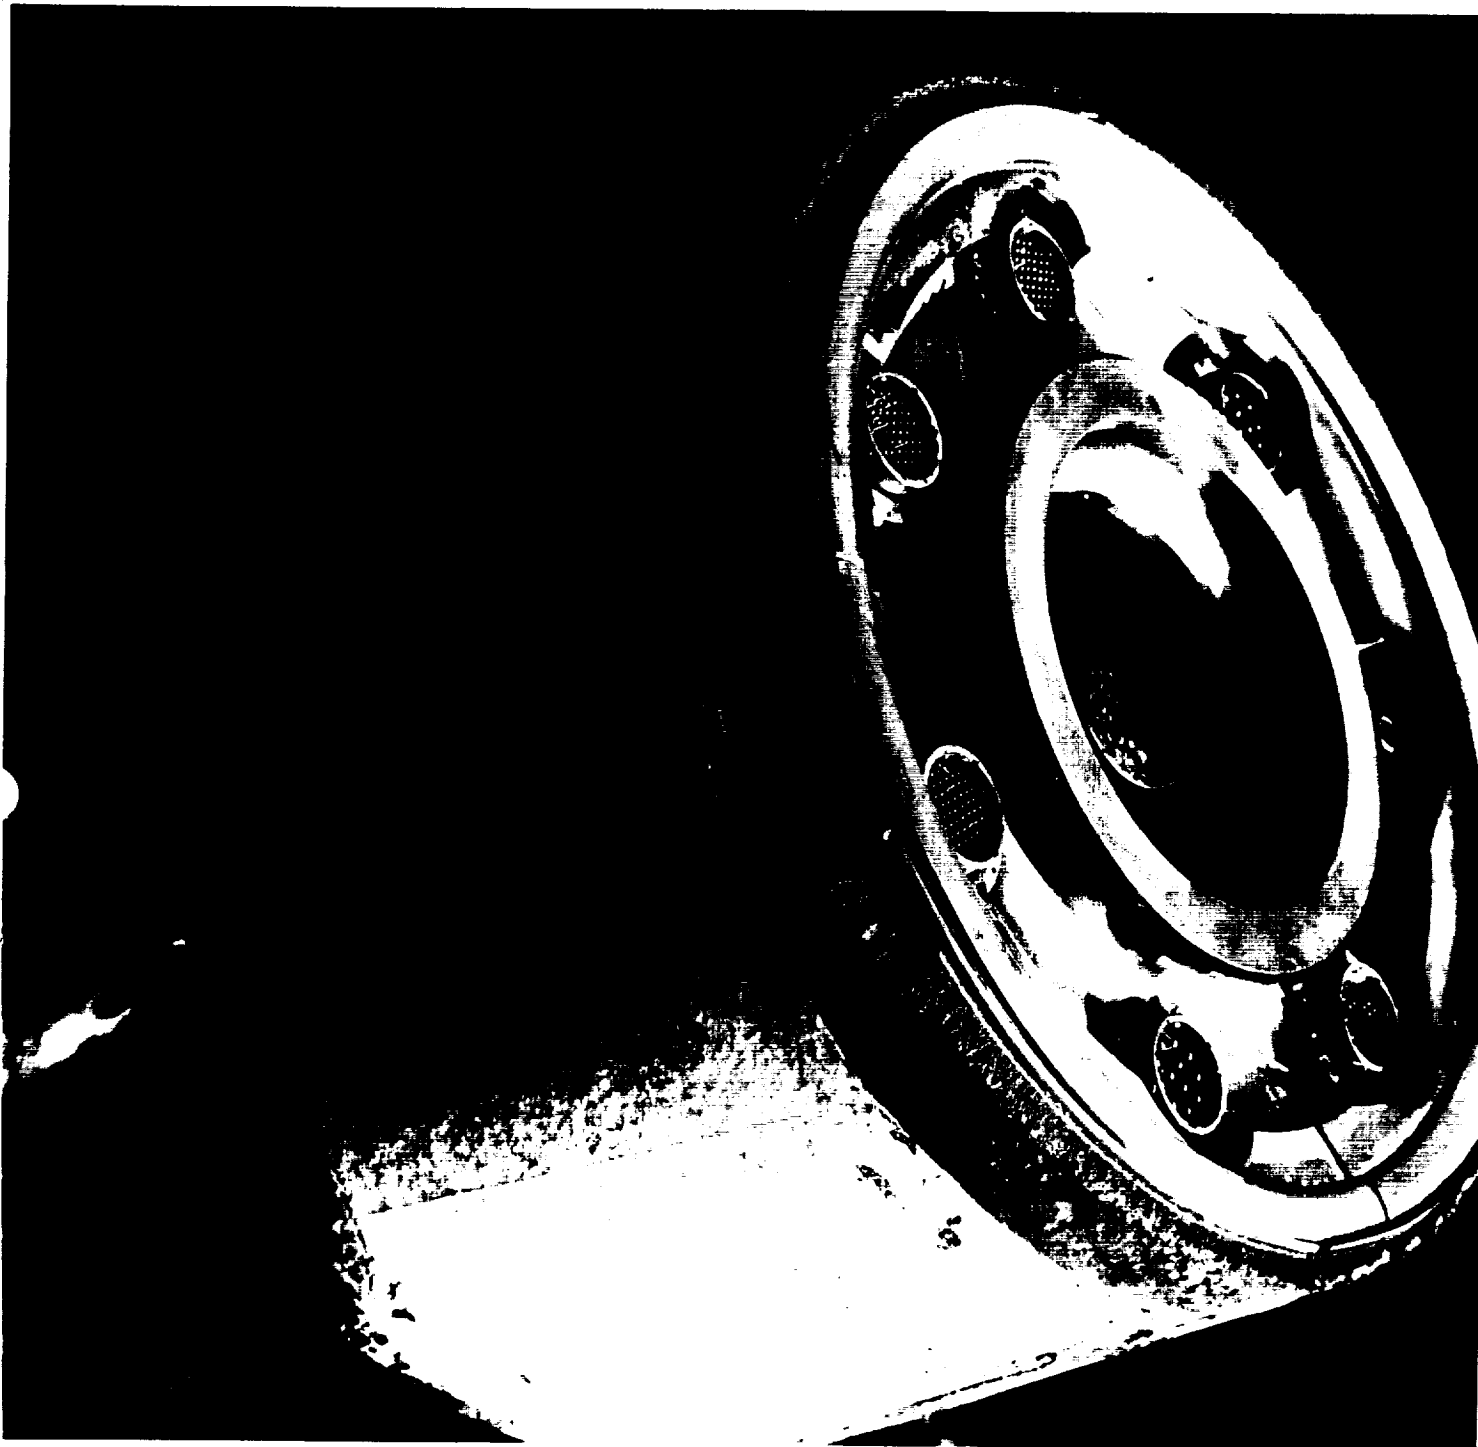
A 6"x3" area of TPS on the forward side of the upper strut fairing at the separation plane was missing and the substrate showed signs of heating. The loss of TPS may have occurred during strut separation.
